A Summary of Test Results for Selective Weakening and Post-tensioning for Retrofit of Non-Ductile R.C. Exterior Beam-Column Joints

2010 NZSEE
Conference

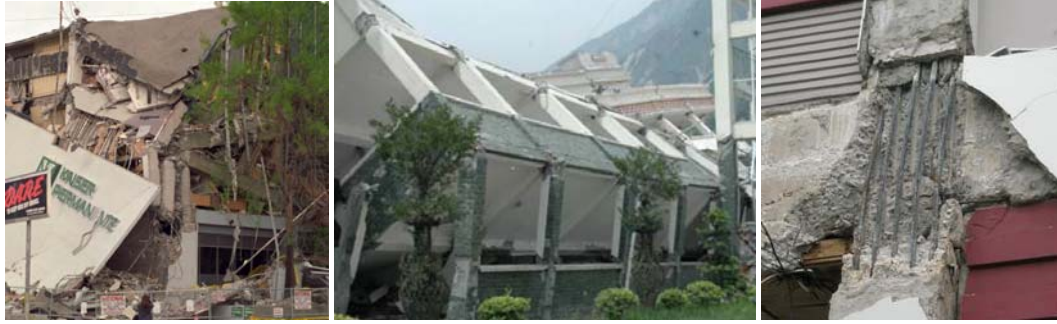
Figure 1: Structural collapse and damage due to b-c joint failures a) Kaiser-Permanente Clinic, Northridge 1994 [3], b) Yingxiu school, Wenchuan, China 2008 [13] c) Femina Hotel, Padang, Indonesia 2009 [10].

Poorly detailed, pre-1970s beam-column (b-c) joints are identified as a critical weakness of non-ductile reinforced concrete (RC) frames. Laboratory tests of non-ductile RC b-c joints [12] as well as field observations in recent earthquakes [3, 13] have further confirmed the seismic vulnerability of these pre-1970s b-c joints. Some examples of structural and soft-storey collapses, initiated from b-c joint failures are presented in Figure 1.

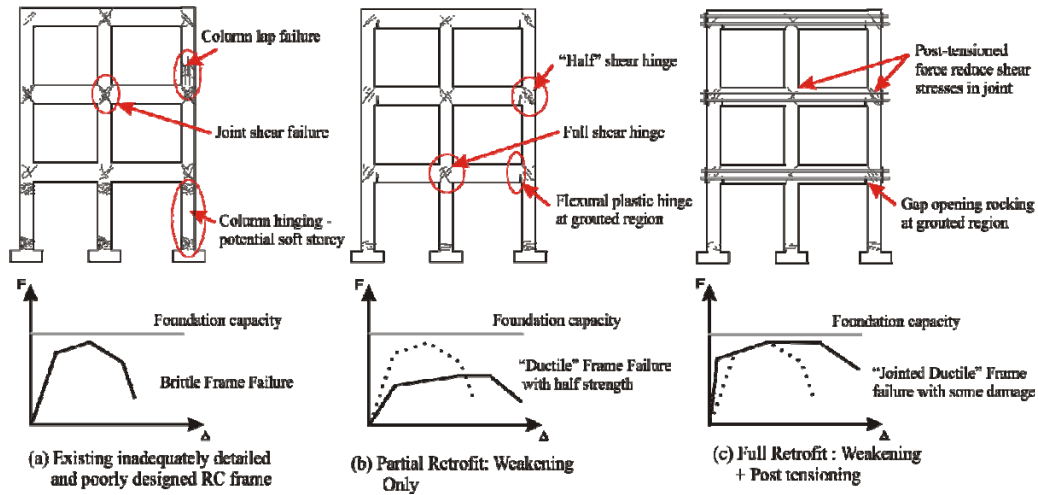
Figure 2: SW retrofit for RC frame: a) Non-ductile RC frame b) Beam weakening-only retrofit c) Beam weakening and external post-tensioning of joint retrofit.

SW retrofit aims to improve global inelastic mechanism and the deformation capacity of the RC frame, by first weakening and then upgrading specific /critical structural (or non-structural) elements, as illustrated in Figure 2. Particularly, to induce a flexural hinge in the beams, some (or all) longitudinal beam reinforcements are cut at the exterior b-c joint faces. The overall frame, whilst weakened, achieves higher deformation and ductility capacity. Further strengthening with external post-tensioning can improve the lateral capacity and energy dissipation, while still respecting the capacities limit of other critical elements (e.g. columns and foundation).

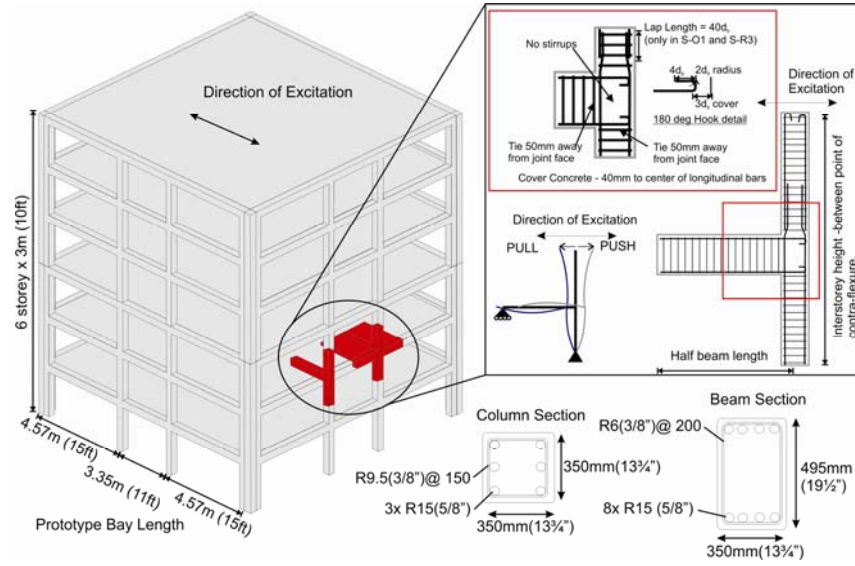
Figure 3: Prototype RC frame and non-ductile detailing and geometry adopted for prototype beam-column joints.

Nine 2/3-scaled exterior b-c joints subassemblies – three as-built and six retrofitted specimens were constructed and tested under quasi-static uni-directional cyclic loading. The prototype b-c joint was designed to represent the worst typical-case in pre-1970s RC construction practice. The joint core had no transverse reinforcement and the beams longitudinal reinforcements were anchored using 180° standard hooks into the joint. Figure 3 shows the prototype RC frame and the reinforcing details adopted for the experiment. In the 2/3-scaled models, all test units had 230mm x 230mm (9x9 inch) columns and 330mm deep x 230mm wide (13x9 inch) beams. Standard steel products were used: mild steel and pre-stressing 7-wire 12.7mm diameter strands with yield strength of 330MPa (47.9ksi) and 1560MPa (226.3ksi) respectively. Other materials and reinforcing details are as given in Table 1.

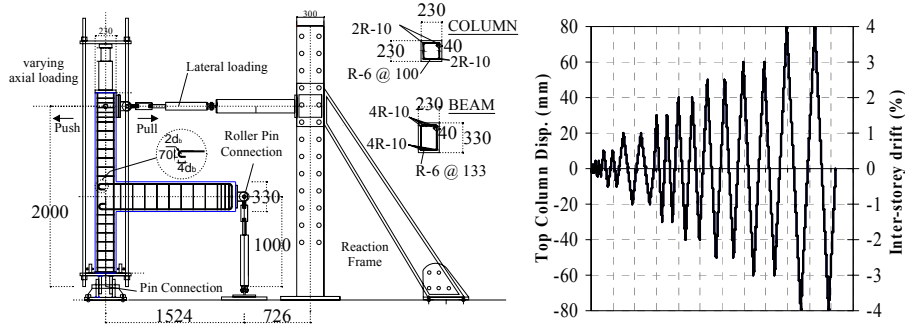
Figure 4: a) Experimental test setup (unit shown are in mm) b) Loading protocol

To simulate earthquake loading, cyclic quasi-static lateral loading was applied horizontally at the top of the column, as shown in the test setup (Figure 4a). The loading protocol used consisted of two displacement-controlled cycles at increasing amplitudes as follows: 0.1%, 0.2%, 0.5%, 1.0%, 1.5%, 2.0%, 2.5%, 3.0% and 4.0% inter-storey drifts (Figure 4b). Varying axial load of $120\text{kN} \pm 4.63F_C$ was implemented, where F_C was the lateral force applied to the top of the column. The varying axial load ratio (4.63) was based on the prototype RC frame shown in Figure 3. For specimens with slab, realistic gravity loadings were added. All the specimens were thoroughly instrumented to measure: a) lateral force applied b) column displacements c) local deformation components, and d) strains in the steel reinforcement.

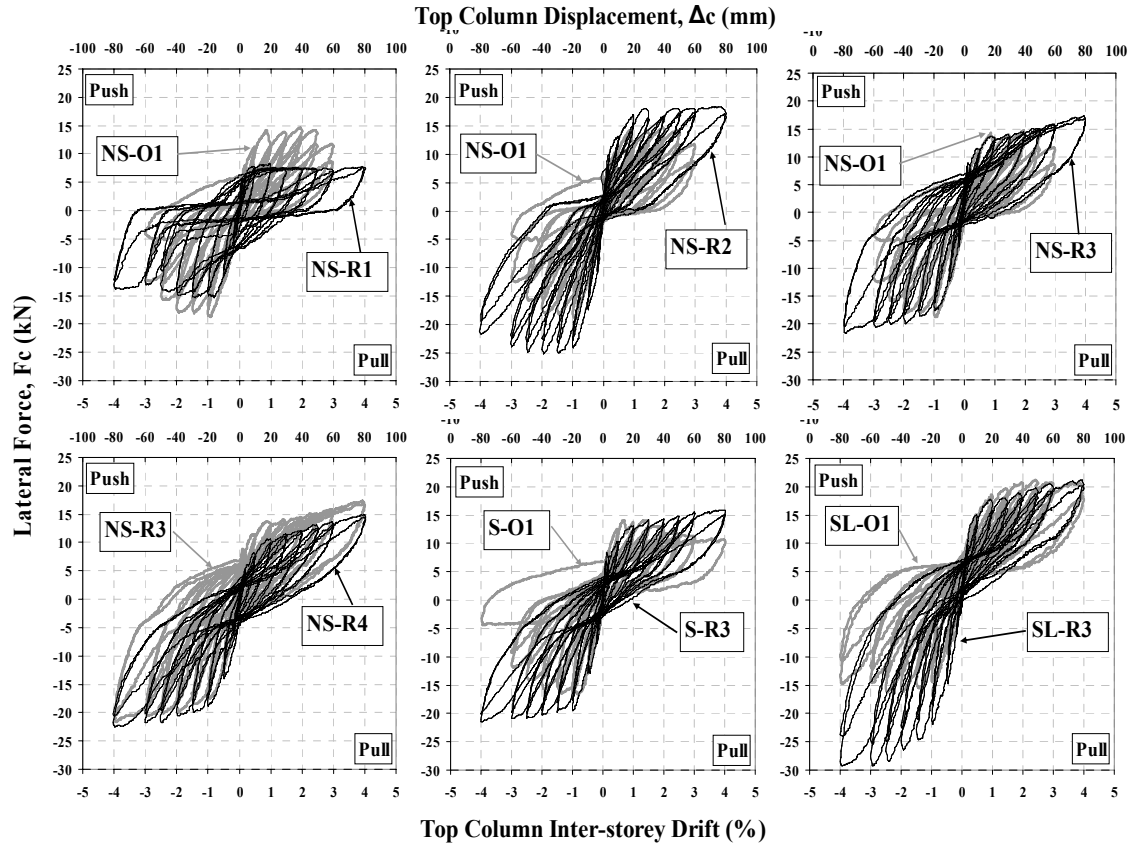
Figure 5: Force-displacement hysteresis curves.

The experimental results are summarized in Table 2 and the associated hysteresis curves of all b-c joints are presented in Figure 5. The final damage patterns of the test units are given in Figure 6. All b-c joints were tested up to 4.0% cycles except for NS-O1, which failed prematurely at the end of the 2nd cycle at 3.0% lateral drift. It is noted that the ‘ultimate’ failure point is defined as the deformation corresponding to the reduction of 20% of the original peak force within the same drift cycle.

Comparison between NS-O1 and SL-O1 shows the effect of the floor slab and transverse beams in delaying the strength degradation beyond joint cracking. For SL-O1, added displacement ductility without increase in lateral strength or joint shear capacity was observed. From Figure 5, it can be observed that the joint region underwent significant shear deformation in SL-O1. Post-experiment forensic inspection revealed similar diagonal shear cracks within the joint region. The apparent ductility of SL-O1 came from the added confinement from the torsional capacity of the transverse beams, based on the observed 54° inclination torsion cracks on the transverse beams. Joint cracking and bond slip nevertheless resulted in pinching hysteresis for SL-O1. Kam et al [9] gives a more comprehensive look on the influence of floor slab and transverse beams on pre-1970s as-built uni-directional and bi-directional b-c joints

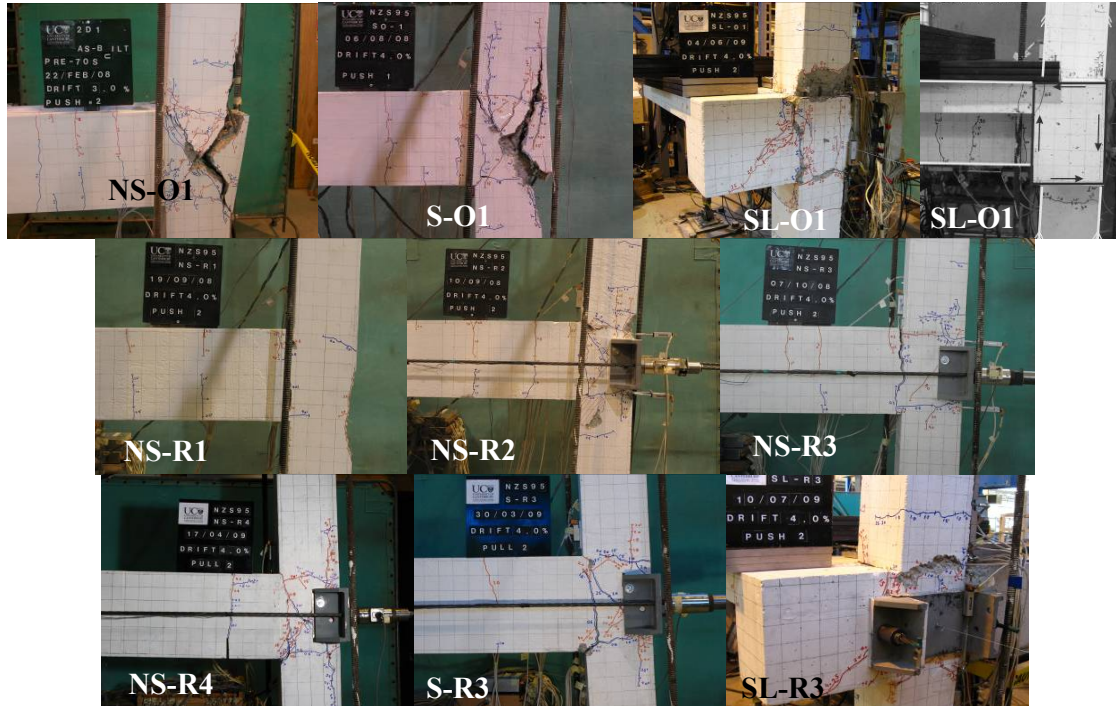
Figure 6: Failure and damage patterns at the end of the tests.

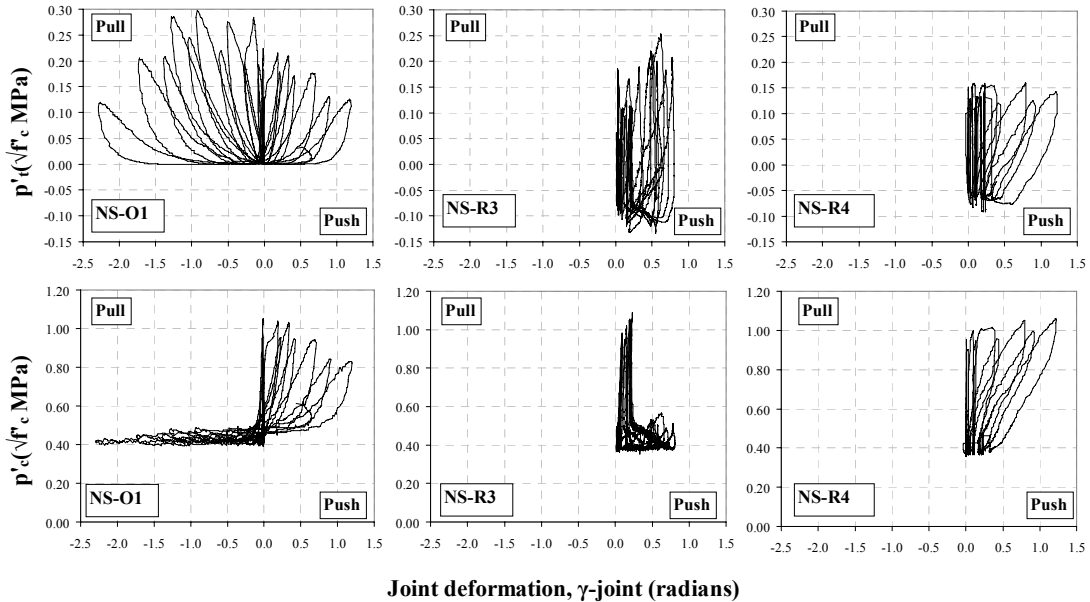
Figure 7: Joint shear deformation and joint principal stresses for NS-O1, NS-R3 and NS-R4.

Three levels of post-tensioning forces were applied (R2: 120kN, R3: 40kN and R4:24kN), with NS-R2 without any beam weakening. External post-tensioning forces affected the extent of beam strengthening and joint strengthening. As all three specimens had beam hinging up to 1.5% drift, after which NS-R2 started having column hinging, the influence of increased level of post-tensioning forces on the beam flexural strength could be identified. Excessive beam-strengthening would lead to column hinging as in NS-R2 for un-bonded post-tensioning, since it would have high post-yield stiffness. At high drifts, the post-tensioning tendon's moment contribution increased due to larger level arm and higher force from tendon elongation. Another drawback of excessive post-tensioning forces was the possibility of diagonal joint compressive failure, which also occurred for NS-R2 at 1.5% drift cycles.

The lower post-tensioning forces led to lower joint shear resistance in the NS-R4. Diagonal joint tensile cracking occurred at 2.0% pull-push drift cycles, when compared with joint tensile cracking at 4.0% drift for NS-R3. Globally, this led to lower energy dissipation and more cyclic strength degradation, when comparing NS-R4 with NS-R3. Evaluating Figure 7, it can be seen that for the as-built NS-O1, the joint failed in principal tensile stress in the Pull direction while it failed in principal compressive stress in the Push direction. Comparing NS-R3 with NR-R4, despite both specimens having roughly the same maximum principal stresses, NS-R4 had more extensive joint damage and deformations in the Push direction. This can be attributed to the lower post-tensioning force in the R4 solution.

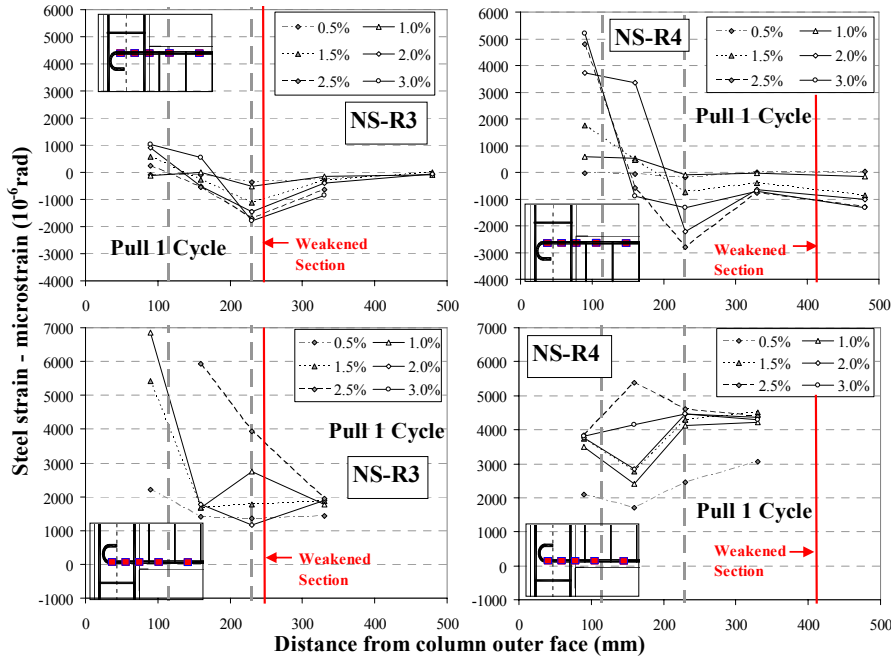
Figure 8: Strain gauge readings for top and bottom longitudinal beam reinforcements for NS-R3 and NS-R4 at 1st peak at Pull direction for different drift cycles. Grey lines are locations for centre-line and inner column faces.

To investigate whether bonds of the beam reinforcements have better capacity in NS-R4, the strain gauge readings for the top and bottom (uncut bars) during the 1st Pull peak cycles were analysed and presented in Figure 8. NS-R4 developed higher steel strains/stresses in both top and bottom reinforcements compared with NS-R3— alluding to the improved anchorage and bond performance of the NS-R4. Bond slip failure occurred in bottom reinforcements during the Push direction, near the b-c face, as the steel strain decreased beyond 1.5% drift cycles. Similarly in Pull 1 cycles, steel strain decreased after 1.5% drift in both specimens. However, it is believed for NS-R3 it was due to bond-slip failure of the bottom reinforcements, while for NS-R4 the strain decrease was due to drop of shear capacity in the joint (after diagonal tensile cracking at 1.5% drift). NS-R4 also clearly illustrated the repeatability of the performance of NS-R3, albeit with lower post-tensioning forces and shifted weakened section.

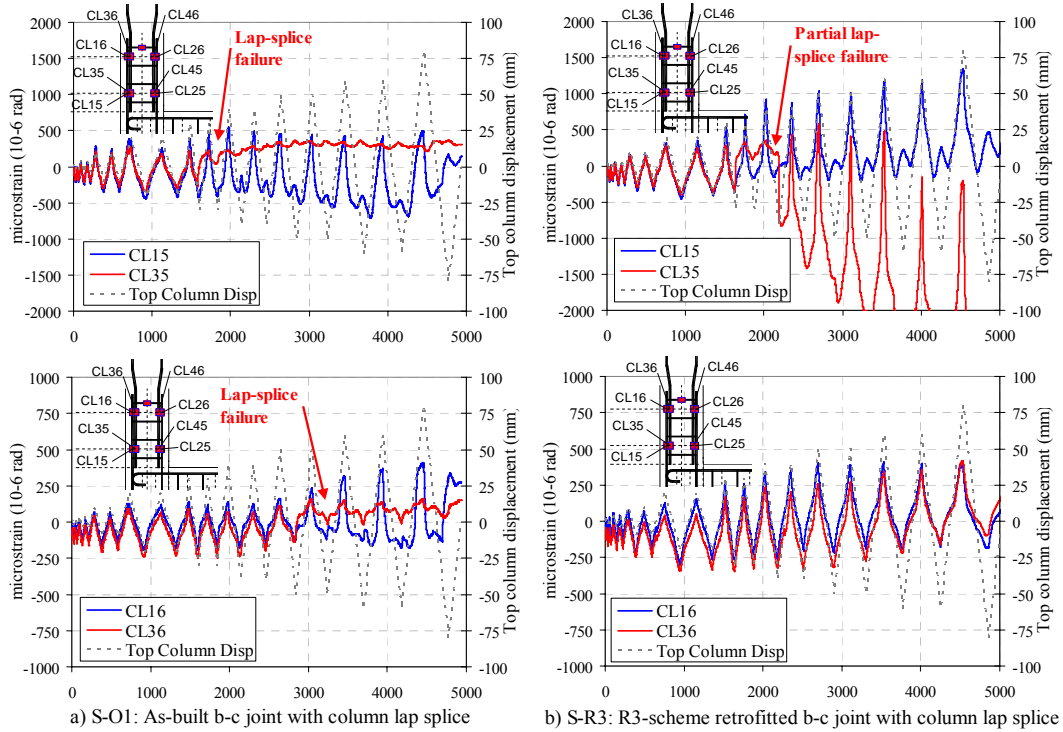
Figure 9: Strain gauge readings for lapped column longitudinal reinforcing bars for S-O1 and S-R3.

Another limiting factor needed to be considered in the assessment/design is the maximum column moment due to column lap-splice capacity. In terms of as-built b-c joints, NS-O1 and S-O1 both had similar seismic performance characteristics, in which joint shear failure led ultimately to column longitudinal bars buckling and ‘structural collapse’. Figure 9a shows strain gauge data evidence for the lap-splice failure in S-O1. While the retrofitted b-c joint S-R3 prevented strength degradation due to joint shear cracking at 2.0% drift cycles, the beam-weakening was not sufficient to completely protect the column from lap-splice failure. Figure 9b indicates partial lap-splice failure in the exterior column bars. This was further supported by lower global post-yield stiffness and vertical cracking the column for S-R3. Nevertheless, with beam-weakening, the detrimental effect of column lap-splice can be minimised. Further mitigation like local jacketing might be necessary if the columns are expected to yield in the post-retrofitted frame (like base columns).
